County Tree Care Ltd

Tree Survey and Arboricultural Impact Assessment of mature large trees and understorey tree species at a site in Carrigaline, Co. Cork

Date : 12/09/21

George Earle, *Dip Arb, TechArbA, Cert Hort*

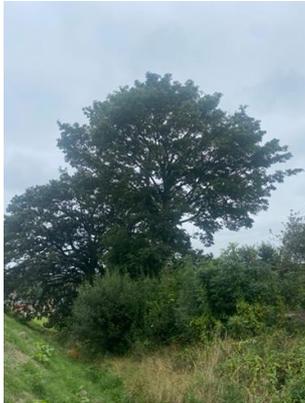
Image A1 : T811

Tag No.	Species	Age	Height	Diameter	Condition	Crown Spread	RPA (M ²)	Comments	Recommendations	RC	ERC
811	Sycamore (<i>Acer pseudoplatanus</i>)	M	16m	105cm (X 2)	Poor	N 7m S 6m E 8m W 5m	499	Hazardous tree, Tall tree on the edge of a earth ditch, drainage dyke running 1m from West side, co-dominant stems @ the base, Northern stem sub-divided @2m, cracking bark and signs of a shear crack on Northern stem from base - 2m East side, Union @2m Northern stem is poor - compressed wood, Large rip out on Southern stem from base to 2m, lack of sufficient structural wood to ensure good structural integrity	Fell Tree	U	< 5

Generally the trees on the site are of fair standard. There are 9no. trees that are recommended to be removed. At the Southern end of the site there are 6no. that are in poor condition. One of these trees T811 is a sycamore (*Acer pseudoplatanus*). This is a hazardous tree and should be removed immediately. The other 5no. in this section are recommended to be felled because of their poor appearance and lack of contributory value to the landscape presently or going forward into the future. This is primarily due to past work that was done on them. T812 is an ash (*Fraxinus excelsior*). This has had all of its branches removed by cutting them back to the main trunk. The result is a burst of epicormic growth (resembling suckers) from the cuts and this means that the tree is now displaying a huge amount of soft leafy growth at different points on the trunk. Aesthetically not pleasing and physiologically compromising. The tree will never have a proper branch structure again and the epicormic growth as it gets heavier can become a hazard as it tends to break off in high winds.

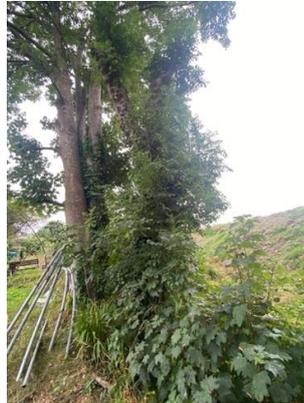
Image A2 : T812

Tag No.	Species	Age	Height	Diameter	Condition	Crown Spread	RPA (M ²)	Comments	Recommendations	RC	ERC
812	Ash (<i>Fraxinus excelsior</i>)	M	7m	45cm	Poor	N 1m S 1m E 1m W 1m	92	Pollarded tree, Main trunk has a proliferation of epicormic growth on the top of the stem and on the sides where branches were cut back all the way to the main stem. It has no shape and offers nothing going forward, epicormic growth in time will be a hazard	Fell Tree	U	< 5

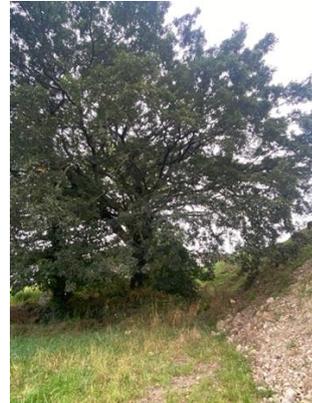
Image A3 : T813

Tag No.	Species	Age	Height	Diameter	Condition	Crown Spread	RPA (M ²)	Comments	Recommendations	RC	ERC
813	Turkey oak (<i>Quercus cerris</i>)	M	15m	90cm	Good	N 11m S 4m E 12m W 9m	366	Healthy oak, growing on an earth bank, dyke running 2m from base on West, crown growing extensively North and East, Some minor dieback on tips @5m NE, NW, dead branches @ 3m N & 5m W, Fine bole to 3m, divides into 5 major limbs at this point, good healthy crown, flush and showing signs of good vigour, lower crown is close to the ground @1.5m	Clean crown of any dead or cracked branches, crown raise to 3m all around NB : Spikes are not to be worn by climbing arborist	A2	50+

There is one tree in category A. It is a Austrian oak (*Quercus cerris*) more commonly referred to as Turkey oak. It is not indigenous and was brought to the British isles in the 1800s as an ornamental tree. It is considered by some to be an invasive species. It is also the host of the knapper gall wasp which can damage native oaks. This tree is growing on the edge of an earth bank next to a drain on the West. Its roots would not have spread extensively Westward. Its crown is slightly underdeveloped on the South because of T811. There is some evidence of minor dieback at the tips on the North-east upper crown and North-west upper crown, but this is minor and not reflective of the health of the tree. The leaf is a good colour and the crown is flush with growth. The main scaffold branches that divide off at 3m are strong and well balanced.

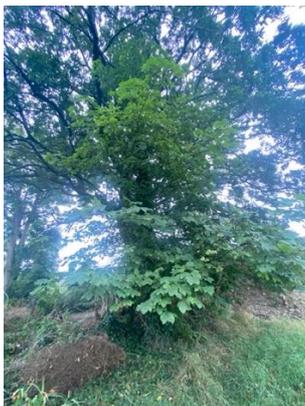
Image A4 : T814

Tag No.	Species	Age	Height	Diameter	Condition	Crown Spread	RPA (M ²)	Comments	Recommendations	RC	ERC
814	Sycamore (<i>Acer pseudo platanus</i>)	EM	12m	20cm	Fair	N 4m S 3m E 3m W 2m	18	Crown unbalanced, tree is growing into T813 on West, 90° of crown is on North and East, Heavy ivy on main stem, tree will never develop in its position and will restrict the oak	Fell Tree	U	<20

There is another tree a sycamore (*Acer pseudoplatanus*) T815 in this section that had the same work done to it as the ash with the same results and prognosis going forward. There is another sycamore T814 that is growing into the Turkey oak (*Quercus cerris*) and will eventually create cambium damage in the oak and restrict branch and leaf development because it is growing within its crown on the North-east side. The sycamore itself will never develop into a well formed tree because of the oak.

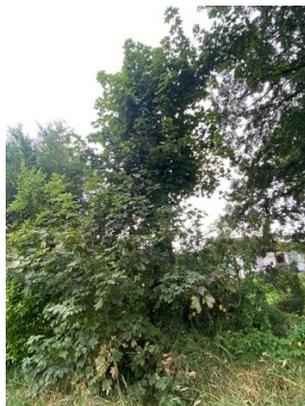
Image A5 : T815

Tag No.	Species	Age	Height	Diameter	Condition	Crown Spread	RPA (M ²)	Comments	Recommendations	RC	ERC
815	Sycamore (<i>Acer pseudo platanus</i>)	EM	6m	30cm	Poor	N 1m S 1m E 1m W 1m	41	Tree was pollarded severely in the past and there is no crown left. Much epicormic growth, much sucker growth at the base. The tree offers nothing to the site presently or going forward.	Fell Tree	U	<10

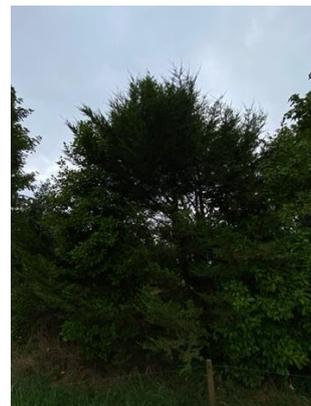
Image A6 : T816

Tag No.	Species	Age	Height	Diameter	Condition	Crown Spread	RPA (M ²)	Comments	Recommendations	RC	ERC
816	Leylandii cypress (<i>Cupressus X leylandii</i>)	EM	5m	30cm	Fair	N 2m S 2m E 2m W 2m	41	Stand alone leylandii as opposed to being in a hedge, Poor crown formation, lower crown all removed, crowded by grisilinia species at the base East & West side, growing in neighbour's garden	Tree is not posing a hazard at present	C3	10+

The other trees on the site are of fair to low quality. One is T816 a leylandii cypress (*Cupressus X leylandii*) Category C3 is located in what might be the neighbour's property and the remaining trees are in the Northern section of the site. There are 2no. Willows (*Salix caprea*) C2, 1no. hawthorn (*Crataegus monogyna*) C1. The others are Alders (*Alnus glutinosa*) 4no. B3, 1no. B2, 1no. C3. These trees that are not great examples structurally or aesthetically but they are of benefit to the site. They are indigenous trees that are commonly found in riparian settings. Alder has many benefits to wildlife. The pollen from the catkin is an early source of pollen for bees and the seeds on the branches are a source of food for fish. They and the willow on the East are densely growing together and offer good shelter on the river bank to small animals and birds.

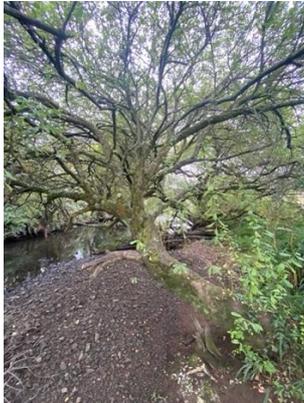
Image A11 : T820

Tag No.	Species	Age	Height	Diameter	Condition	Crown Spread	RPA (M ²)	Comments	Recommendations	RC	ERC
820	Willow (<i>Salix caprea</i>)	M	4m	30cm	Poor	N 3m S 2m E 6m W 4m	41	Growing on the side of the riverbank, signs of decay on the main stem @2m, deadwood @1m,2m & throughout crown	Retain as part of riverbank hedgerow, cut back to field edge on West reduce to 4m in height	C2	10+

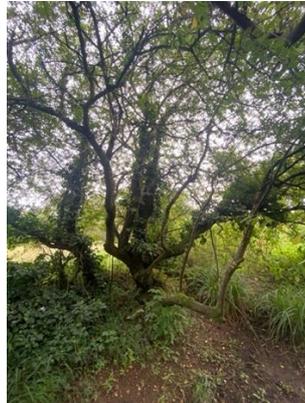
Image A12 : T821

Tag No.	Species	Age	Height	Diameter	Condition	Crown Spread	RPA (M ²)	Comments	Recommendations	RC	ERC
821	Hawthorn (<i>Crataegus monogyna</i>)	M	6m	30cm	Fair	N 2m S 1m E 2m W 2m	41	Mature tree growing on the side of a river bank, leaning 80° East, minor ivy on main stem, poor lower crown formation, no branches due to poor light levels from dense crown overhead of T820, growing into T820 on South	Clean crown, cut top to 4m and cut West side, retain, as with willows, as part of riverbank hedgerow	C1	10+

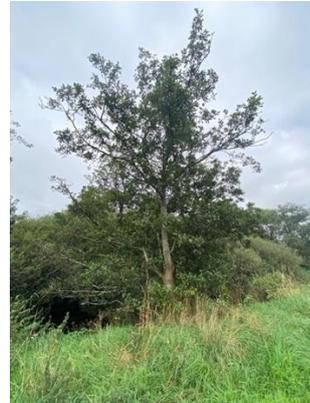
Image A13 : T822

Tag No.	Species	Age	Height	Diameter	Condition	Crown Spread	RPA (M ²)	Comments	Recommendations	RC	ERC
822	Alder (<i>Alnus glutinosa</i>)	M	5m	65cm (X 3)	Fair	N 4m S 3m E 3m W 3m	191	Growing over river to the North, crown heavy over river, broken branches @2m, South side lower crown, branches growing into field on South by 1m	Cut back branches to field edge on South, clean crown of any broken branches, retain as part of a riverbank tree group	B3	20+

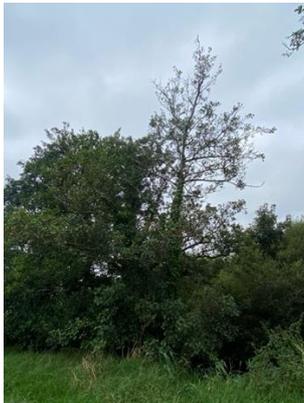
Image A14 : T823

Tag No.	Species	Age	Height	Diameter	Condition	Crown Spread	RPA (M ²)	Comments	Recommendations	RC	ERC
823	Alder (<i>Alnus glutinosa</i>)	M	7m	40cm (X 2)	Poor	N 3m S 2m E 2m W 0m	72	Dieback in the tips of the crown, tree is growing out from base of T824, leaning East 70° poor crown formation, weak tree	Fell tree as it will present a hazard in time	U	< 5

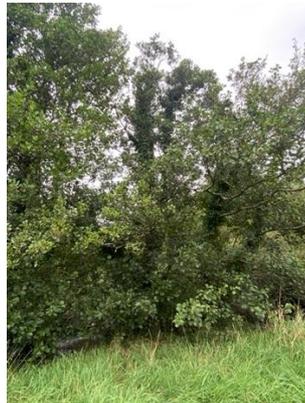
Image A15 : T8124

Tag No.	Species	Age	Height	Diameter	Condition	Crown Spread	RPA (M ²)	Comments	Recommendations	RC	ERC
824	Alder (<i>Alnus glutinosa</i>)	M	7m	40cm (X 2)	Poor	N 4m S 4m E 2m W 3m	72	Poorly shaped crown, impeded on East by T823 and West by T825, growing North over river, minor crown growth to the South, Heavy ivy on main stems and into crown, crowded and will not develop	Fell Tree and create space for T825 to develop its crown	U	< 2

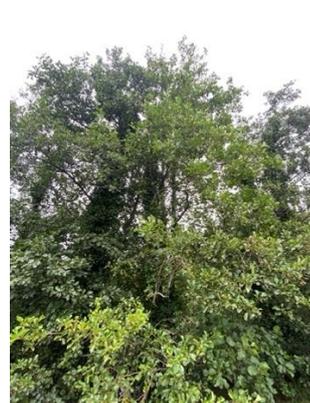
Image A16 : T825

Tag No.	Species	Age	Height	Diameter	Condition	Crown Spread	RPA (M ²)	Comments	Recommendations	RC	ERC
825	Alder (<i>Alnus glutinosa</i>)	M	8m	30cm	Fair	N 3m S 4m E 2m W 5m	41	Co-dominant stems from the base, heavy ivy growth on main stems into upper crown, poor crown formation, impeded on West by T824 and East by T826	Remove ivy, clean the crown of any defective branches, cut back branches on South to field edge, retain tree as part of a riverbank tree group	B3	20+
